Power Transmission Group  
Our Drive – Your Success

# Technical *Info*

## TI 1-25

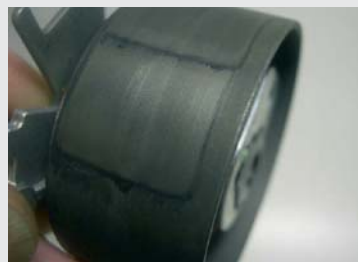
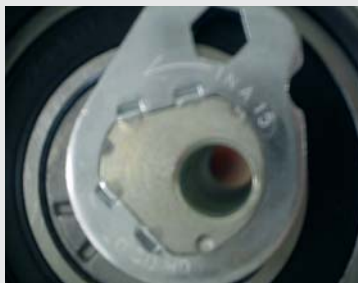
The tensioner pulley collapses after a short running time and possibly has a separate barrel jacket from the bearing core.

The barrel jacket has mostly strong traces of rubbing. The back of the timing belt is often considerably damaged, and sometimes even completely worn due to heat application.

Due to the eccentric being rotated in the wrong direction, the tensioner pulley reaches an impermissible position and makes contact with a protruding edge in the motor pinion. The tensioner pulley is thereby completely or partially mechanically blocked and the belt which continues to turn is overheated on the barrel jacket. The level of damage depends on the running time..

Always install the timing belt exactly according to the manufacturer's instructions and in particular, comply with the rotational direction of the eccentric for tensioning. **(anti-clock-wise here)** Otherwise the tensioner pulley can come into contact with a protruding edge and short-term failure is very likely.

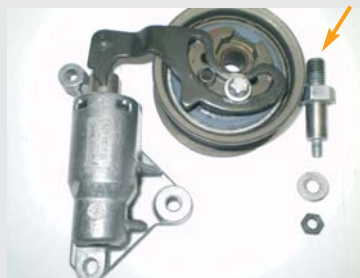
## The version to be replaced (1)

Different thicknesses of spacer **(3.1)+(3.2)** which define the distance from the roller to the engine. Despite the Vehicle Identification No. delimitation (prod. month: 01/96) it is still not absolutely unequivocal which kit must be used since the stated Vehicle Identification No. can deviate from this. One should always check whether the replaced tension roller is mounted aligned in the belt drive. There will definitely be noises produced otherwise or even grave damage to the engine.

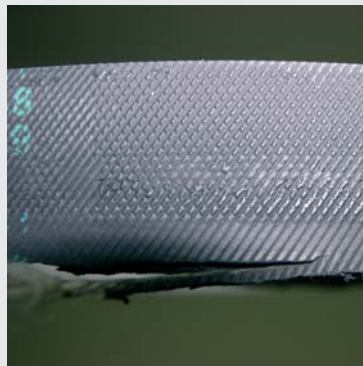
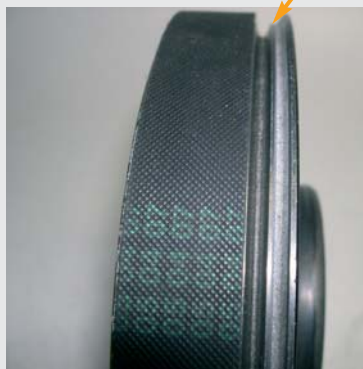
## Type to be replaced

The belt is very noisy, wears quickly and exhibits signs of abrasion. Because of the sideways oscillation, the tensile member, including the ribs, might rip out of the belt. If a timing belt starts slipping as a result, this can, in turn, lead to serious engine damage.

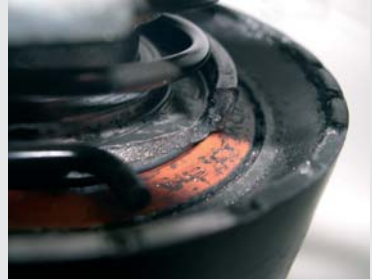
Fig. 1

A cast part has broken off the tension roller or the spring is broken.

The oil contamination caused the failure of the roller (excessive oscillation of the spring). It must always be checked to ensure that the shaft sealing rings on the crankshaft/camshaft function properly. If required they must be replaced.

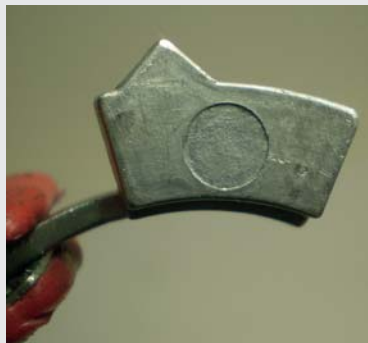
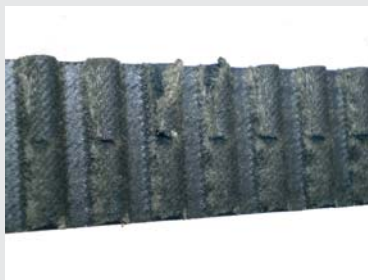
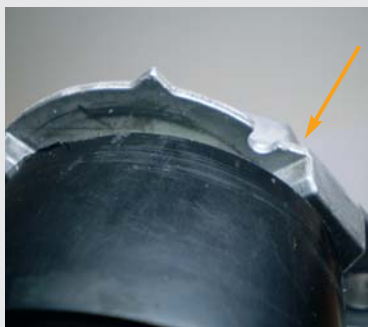
The pointer on the tension pulley breaks off during installation and could severely damage the belt.

1. Failure to loosen the water pump and to use it for adjusting the tension as described in the instructions.
2. During the specified two-fold rotation of the engine at increased tension (hole marking on the baseplate) the limit stop is subjected to excessive load and the movable pointer breaks off.

1. Make sure that the water pump is loosened, then turned using the corresponding tool OE (J-4249 2) and finally tightened again to 8 Nm.
2. The tongue of the pointer must be adjusted to ensure that it bears no load at any time. After turning the engine twice, both pointers must be perfectly aligned with one another.

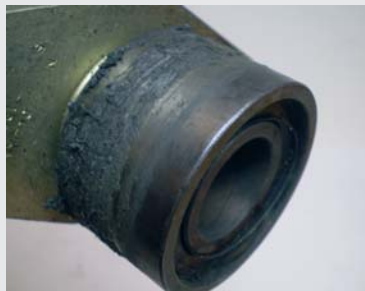
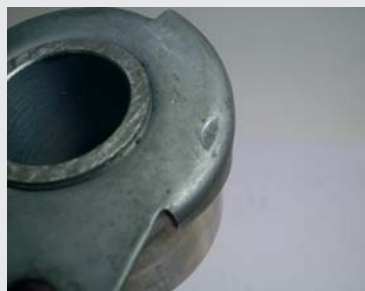
The tension pulley gets locked after a short period of operation. The back of the belt becomes overheated and the idler pulley suffers thermal damage.

During tension pulley installation, attention was not paid to ensure that the pulley revolves around its axis properly and/or the nut is tightened sufficiently. This caused the pulley to twist under load and the jacket was blocked on the inside by a bent retaining plate.

1. Care must always be taken to ensure that the tension pulley is correctly installed on the mounting surface (lug must be properly seated in the recess of the retaining plate).
2. In addition, the specified tightening torque of 50 Nm must be observed during installation.
