### Aligning the Hood by Russ Furstnow

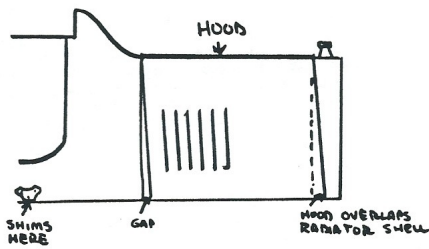
After completing the restoration of a 1921 touring, we noticed the hood did not align up very well with the

The solution proved to be fairly easy. The body was raised in relation to the height of the radiator, and the

When everything was tightened down, the hood fit perfectly and no longer rubbed the paint from the radiator.
