Power Transmission Group  
Our Drive – Your Success

# Technical *Info*

## TI 1-25

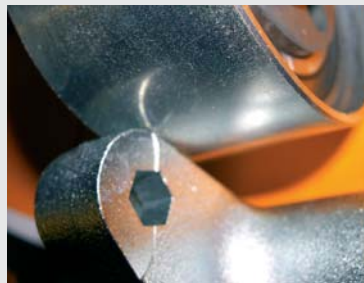
Fig. 1

The tension lever chafes against the tensioning pulley. (Fig. 1) This can result in serious damage to the engine.

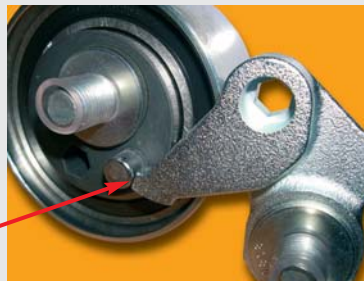
Fig. 2

Due to improper positioning during installation (Fig. 2), the tensioning lever comes into contact with the barrel jacket after the parts have been in operation only briefly. By way of illustration, the side facing the engine is shown here. (It is otherwise not visible.)

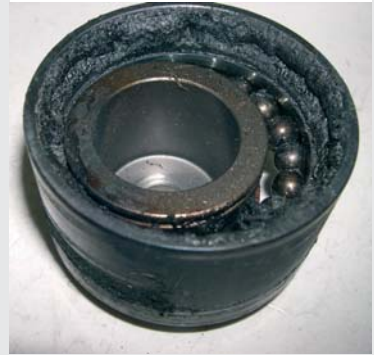
Fig. 1

Shortly after the kit has been installed, the idler pulley fails due to degradation/overheating. (Fig.1)

Disassembled idler pulley

The tension pulley must absolutely be clamped counterclockwise when an eccentric is used for clamping. The roller must be able to move freely on the assembly stand. The tightening torque of 48 Nm on the fixing screw must be observed.

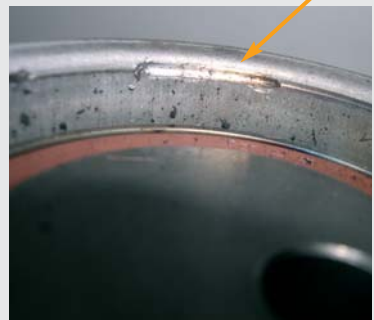
Fig. 2

Blockage of the tension pulley. This causes the belt that transmits heat to the idler pulley to overheat. As a result, the plastic cage of the bearing melts, causing the roller to fail. The blockage of the tension pulley occurs when the roller rubs against the assembly stand. (Fig. 2)

Tension pulley inside mech. blocked

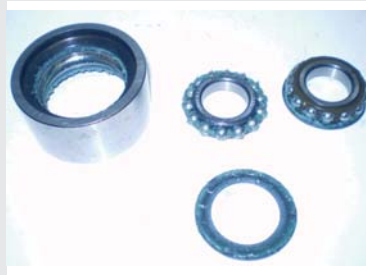
The tension pulley supplied with the kit breaks apart after a short period of operation, normally resulting in damage to the engine.

This is due to faulty alignment of the belt drive. The tension pulley is subjected to off-center loading and fails after a short running time.

## **Disassembled bearing**

To ensure correct belt alignment, it is vital that the tension pulley holder is cleaned thoroughly, and that you subsequently check that the entire surface of the pulley is properly seated on the guide pin.

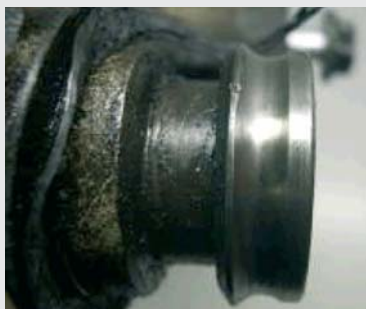
## **Guide pin of the tension pulley retaining plate**

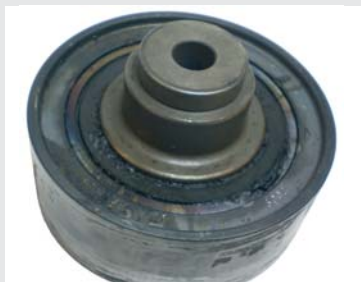
Fig. 1

The large idler pulley breaks away following a short period of operation due to bearing blockage. This can lead to engine damage (**Fig. 1**).

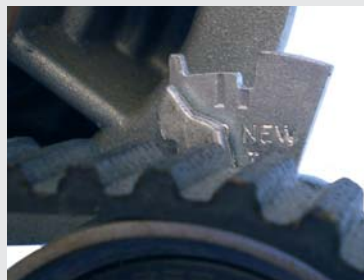
## Pointer position too low

The tension pulley makes noises after operating a certain amount of time. In subsequent operation, the arrester can break and the belt loses its tension. As a rule, this results in damage to the engine!

Opel/GM specifies a special process for setting the tension when a timing belt is changed: When tensioning, the adjusting cam is to be turned counterclockwise (to the left). The timing belt drive must be rotated 2x by hand with fully tensioned tension pulley. Only after this has been done is the tension to be set by turning the cam to the right to the "new" mark. This must be done to ensure that the timing belt is "set".

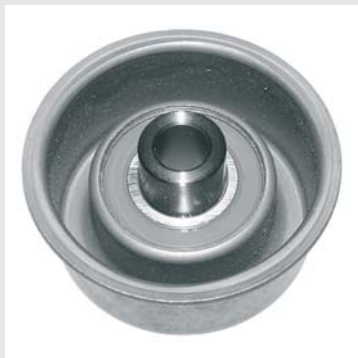
Fig. 1

Old idler pulley V 55317

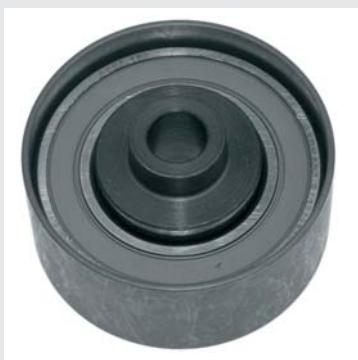
Fig. 2

New idler pulley V 55368
